Project Spotlight KYMAX

OKA Towers - Guam

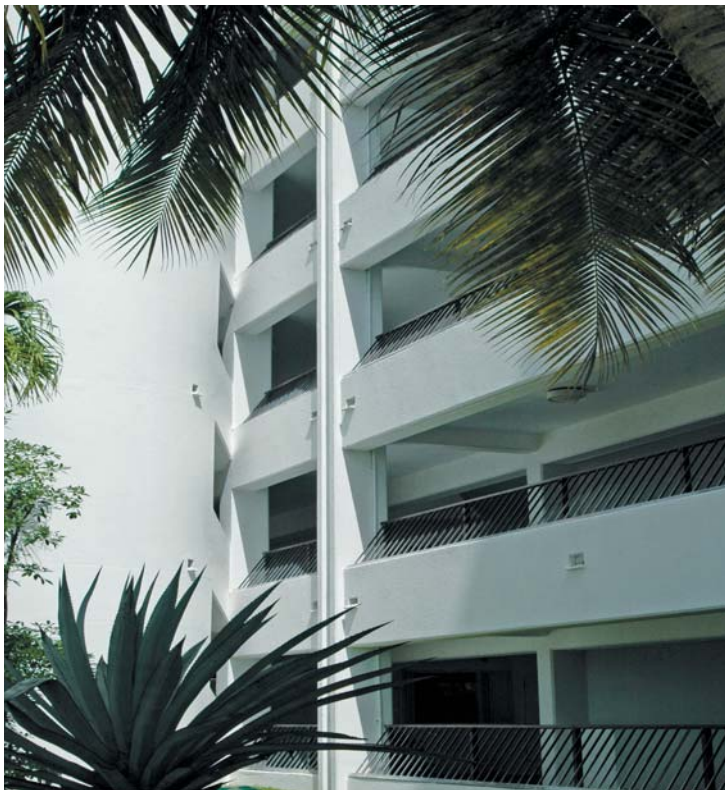
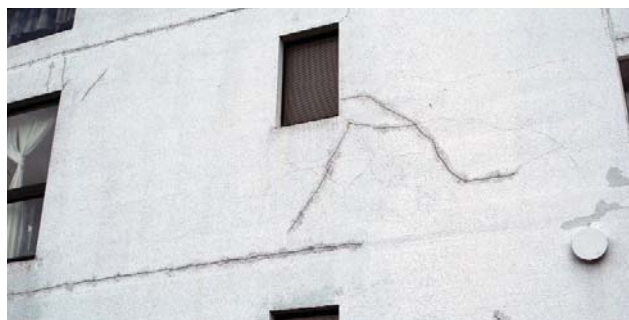
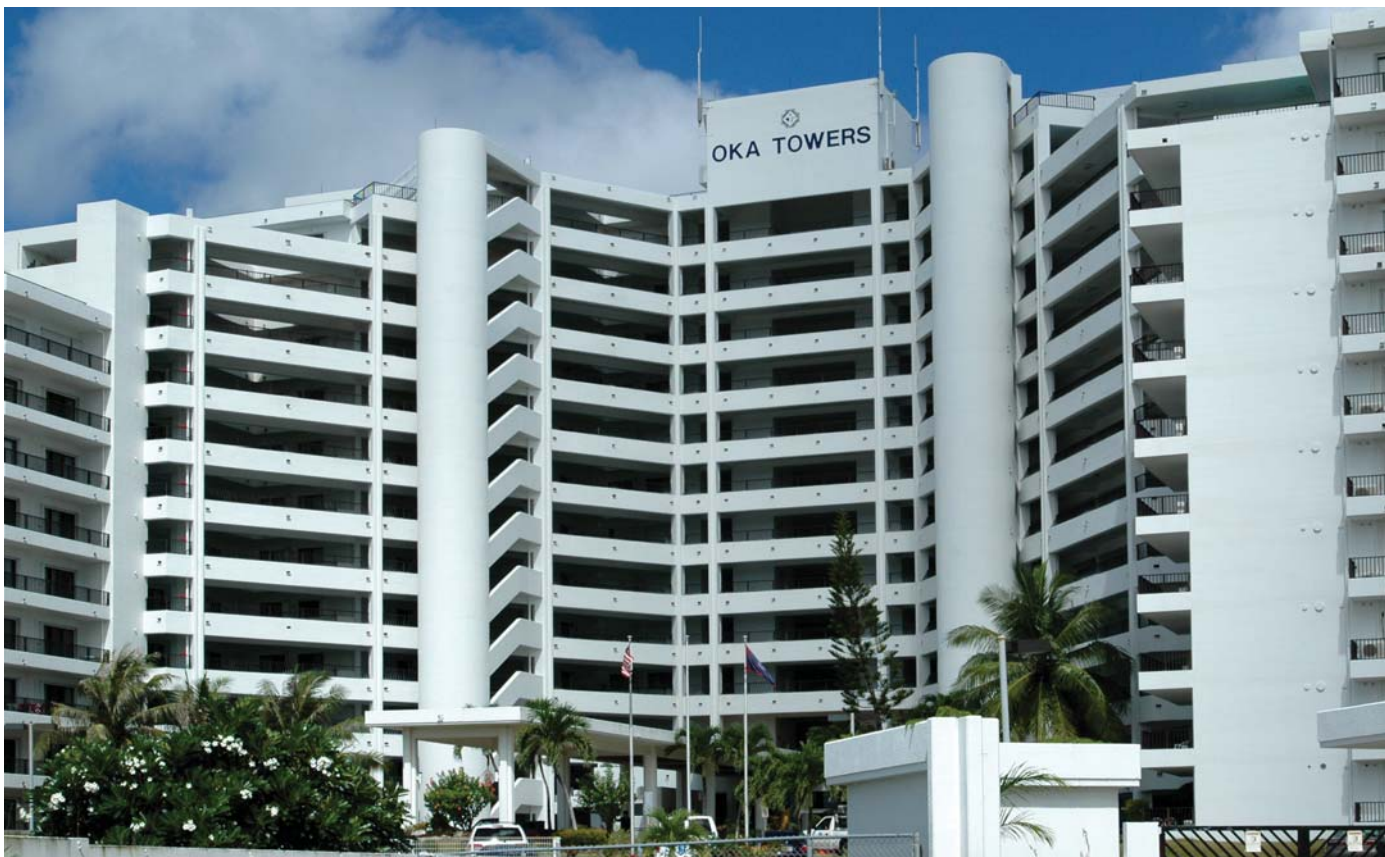
The existing textured coating on this high-rise apartment building had suffered extensive damage due to Guam's severe tropical environment. Perched on cliff 70 feet above the ocean, the building is frequently subjected to typhoon force winds in excess of 170 mph, along with salt spray and strong UV rays. Over time, some of the existing coating had actually been worn smooth due to the abrasive nature of these elements.

Wall-Bond 90, acrylic-modified cement, was recommended to reproduce the textured finish. The Wall-Bond 90 was able to perfectly reproduced the original random free spray profile. Cracks were filled with polyurethane caulk, spalls repaired using UNITED'S Unicrete, and corrosion on the railings treated with UNITED'S Lock-Down Primer.
